Use of light-weight steel strapping as external reinforcing to concrete beams

USE OF LIGHT-WEIGHT STEEL STRAPPING AS
EXTERNAL REINFORCING TO CONCRETE BEAMS

THESIS

MASTER OF SCIENCE IN CIVIL ENGINEERING

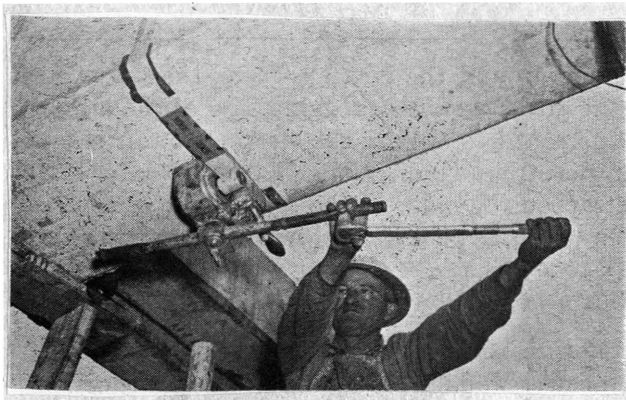
Figure 17

Tensioning operation. Force being applied on torque indicator.

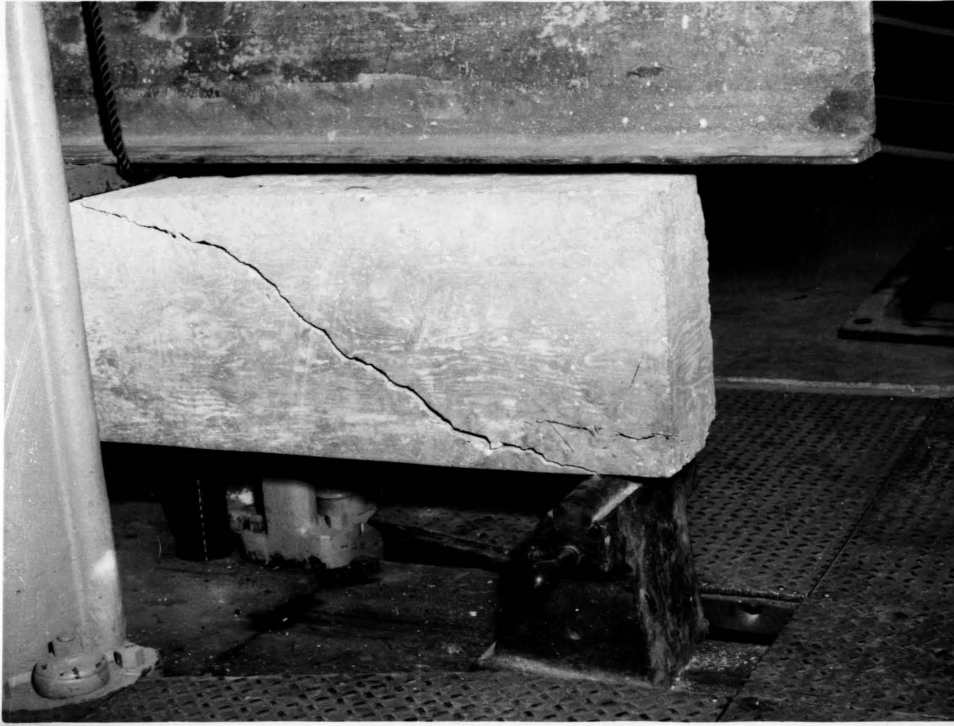
Figure 24

Failure of Beam No. 2

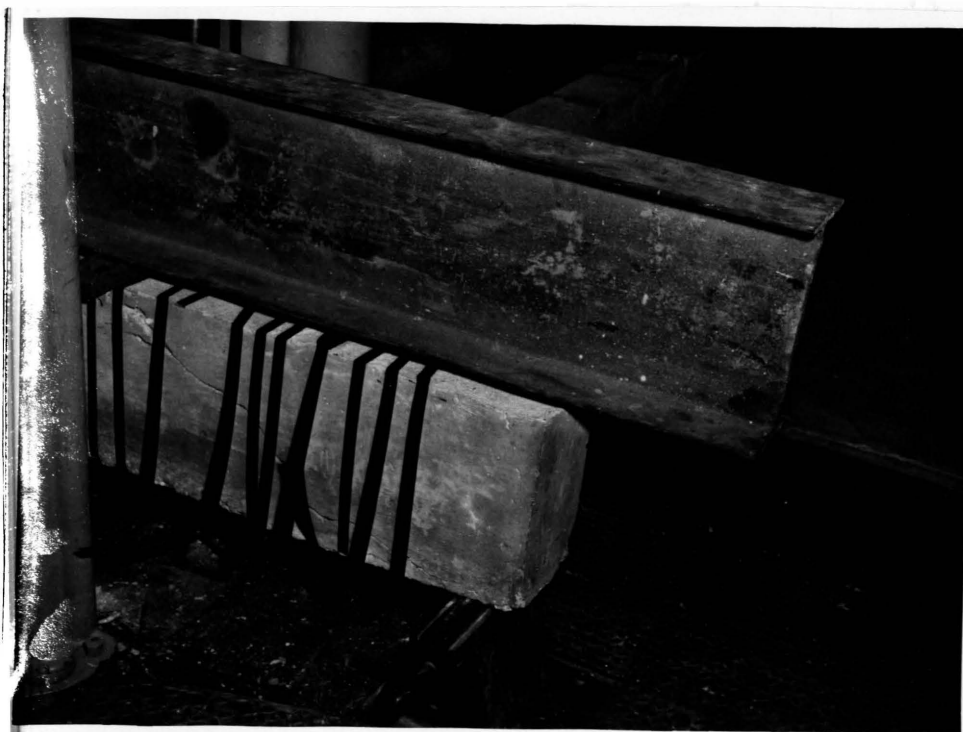
Figure 26 - Beam after testing

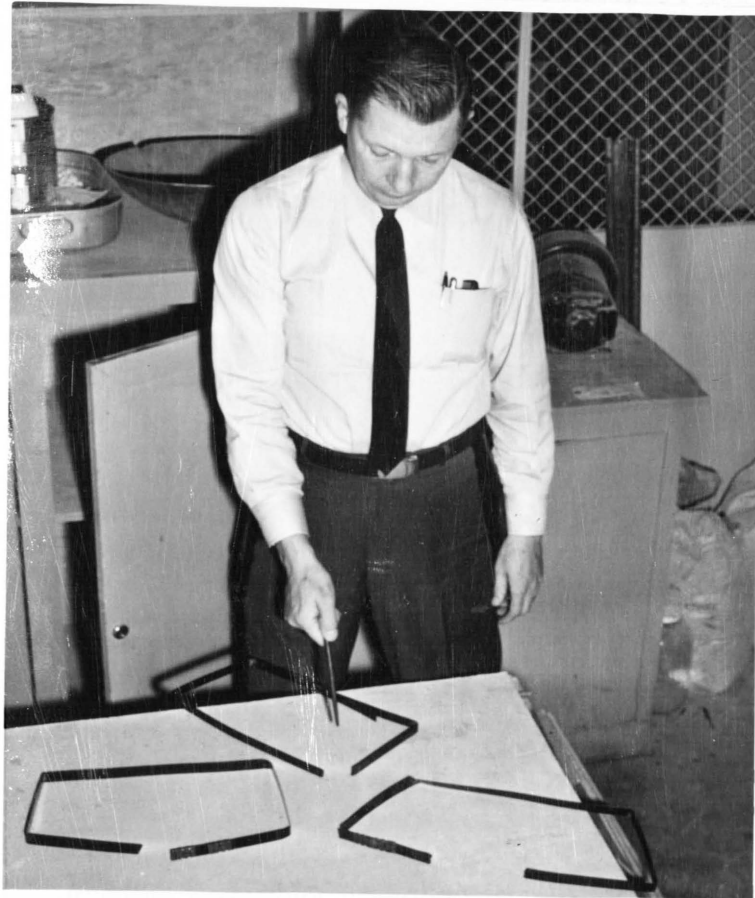
Note the three
different types of
strap failures.

1. Corner break
2. Side break
3. Clamp break

The most common type
of failure was the
corner break.

Sharp corners caused straps to break sooner than necessary. Corner failures were the most common observed in this test. However, there were some straps which broke on the sides of the beam
